15 YEARS LATER: ON THE PHYSICS OF HIGH-RISE BUILDING COLLAPSES

■ Steven Jones¹, Robert Korol², Anthony Szamboti³ and Ted Walter⁴

■ ¹Brigham Young University (early retired) – ²McMaster University (emeritus) – ³Mechanical design engineer in the aerospace industry – ⁴Architects & Engineers for 9/11 Truth – DOI: <http://dx.doi.org/10.1051/eprn/2016402>

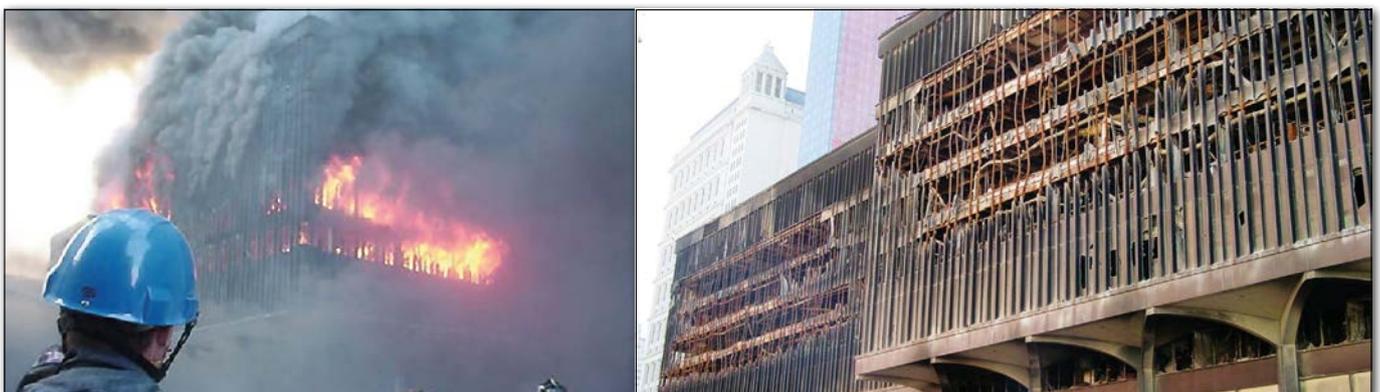
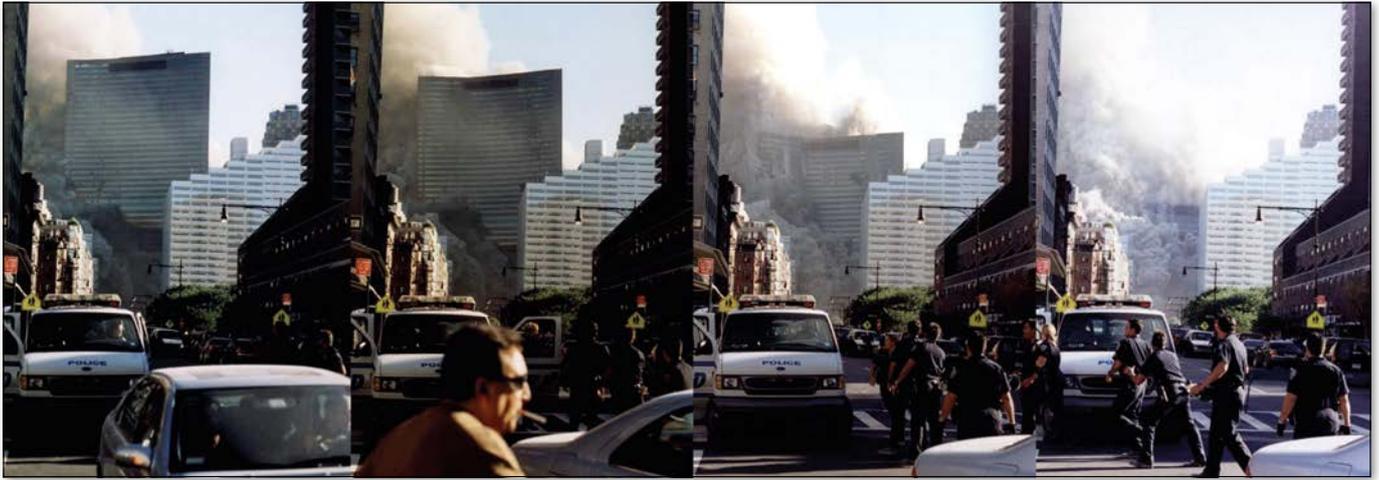
▼ FIG. 1: WTC 5 is an example of how steel-framed high-rises typically perform in large fires. It burned for over eight hours on September 11, 2001, and did not suffer a total collapse (Source: FEMA).

Throughout history, three steel-framed high-rises are known to have suffered partial collapses due to fires; none of those led to a total collapse. Countless other steel-framed high-rises have experienced large, long-lasting fires without suffering either partial or total collapse (see, for example, Fig. 1a and 1b) [1].

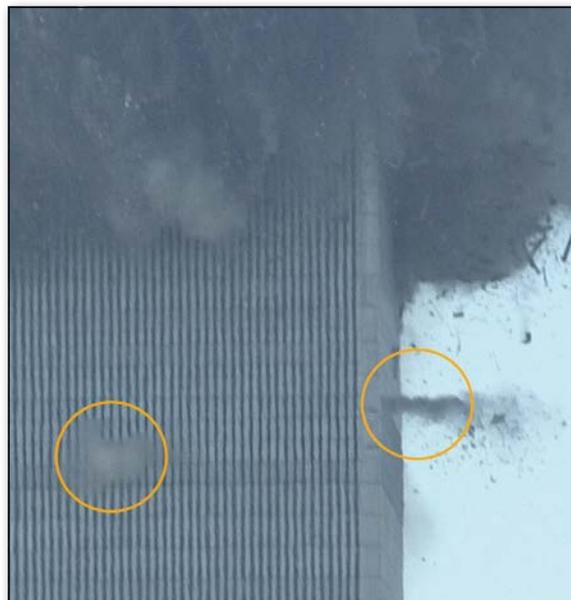
◀ FIG. 5: High-velocity bursts of debris, or “squibs,” were ejected from point-like sources in WTC 1 and WTC 2, as many as 20 to 30 stories below the collapse front (Source: Noah K. Murray).

The collapse mechanics discussed above are only a fraction of the available evidence indicating that the airplane impacts and ensuing fires did not cause the collapse of the Twin Towers. Videos show that the upper section of each tower disintegrated within the first four seconds of collapse. After that point, not a single video shows the upper sections that purportedly descended all the way to the ground before being crushed. Videos and photographs also show numerous high-velocity bursts of debris being ejected from point-like sources (see Fig. 5). NIST refers to these as “puffs of smoke” but fails to properly analyze them [6]. NIST also provides no explanation for the midair pulverization of most of the towers’ concrete, the near-total dismemberment of their steel frames, or the ejection of those materials up to 150 meters in all directions.

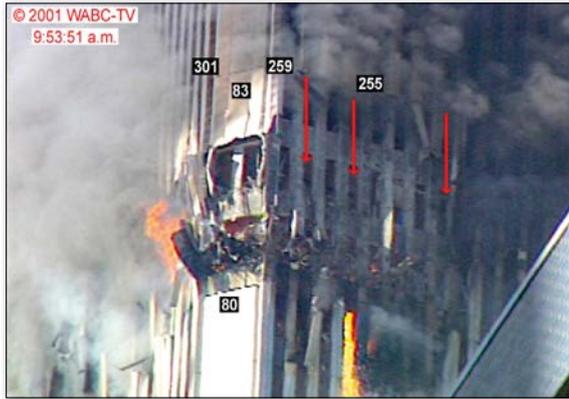
► **FIG. 6:** Molten metal was seen pouring out of WTC 2 continuously for the seven minutes leading up to its collapse (Sources: WABC-TV, NIST).

NIST sidesteps the well-documented presence of molten metal throughout the debris field and asserts that the orange molten metal seen pouring out of WTC 2 for the seven minutes before its collapse was aluminum from the aircraft combined with organic materials (see Fig. 6) [6]. Yet experiments have shown that molten aluminum, even when mixed with organic materials, has a silvery appearance—thus suggesting that the orange molten metal was instead emanating from a thermite reaction being used to weaken the structure [12]. Meanwhile, unreacted nano-thermitic material has since been discovered in multiple independent WTC dust samples [13].
